MTMC REPORT OA 77-2

**ANALYSIS  
OF MTMC PARTICIPATION  
IN THE  
REFORGER 77 EXERCISE**

FEBRUARY 1978

**MILITARY TRAFFIC MANAGEMENT COMMAND  
TRANSPORTATION ENGINEERING AGENCY  
NEWPORT NEWS, VIRGINIA 23606**

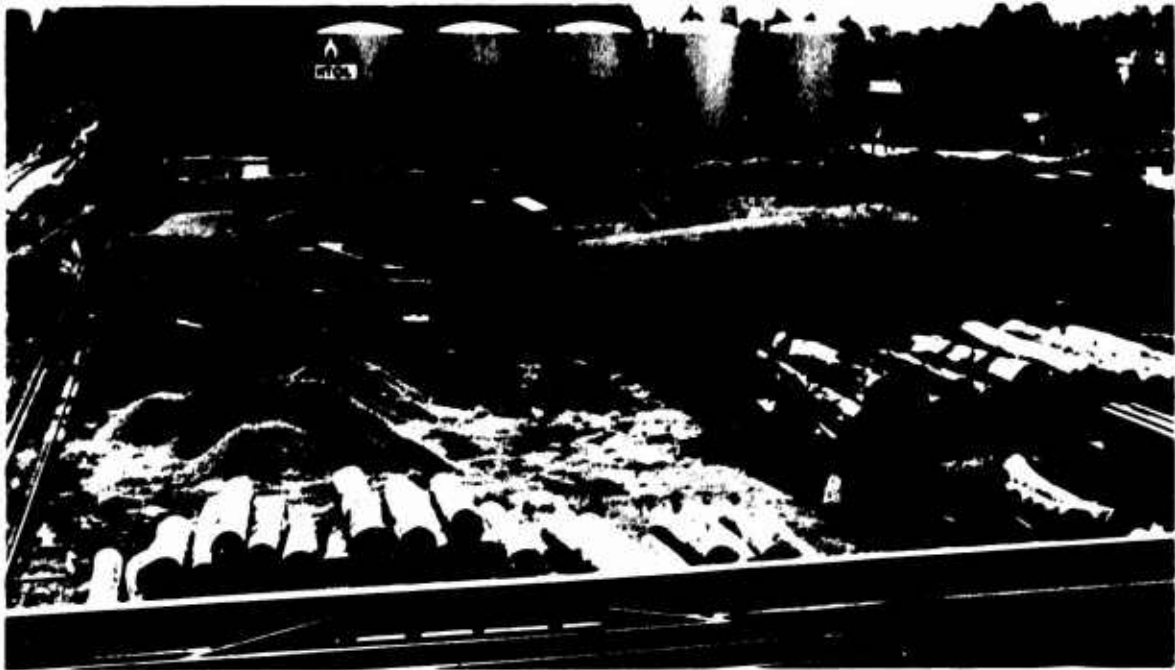
Figure 11-9. Staging at Rheinau.

d. Equipment was staged by type (figs 11-9 and 11-10) or was loaded directly from highway assets to the barge (fig 11-11).

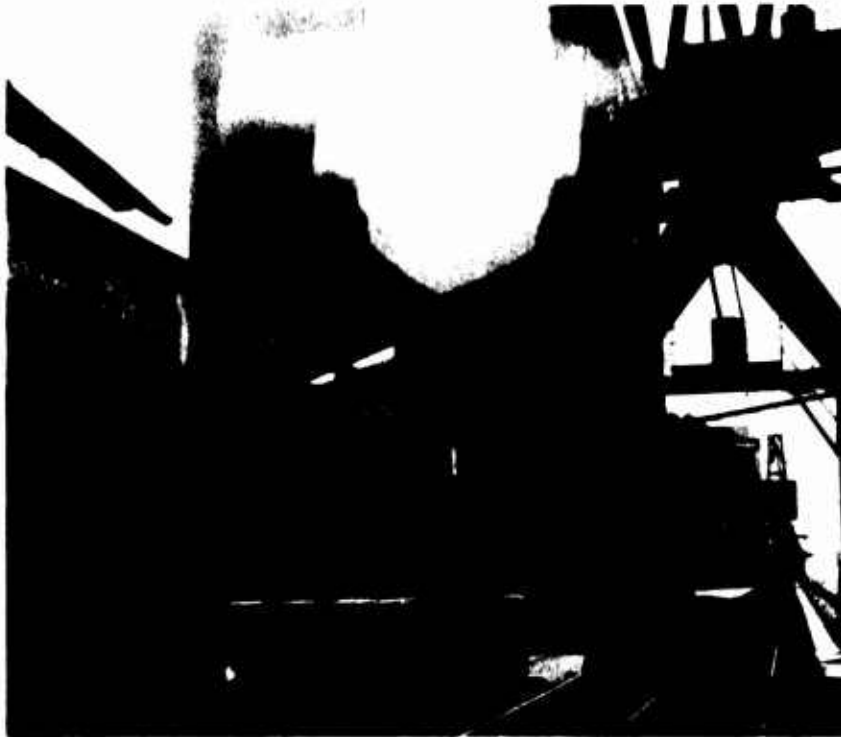
Figure 11-11. Truck off-load to barge.

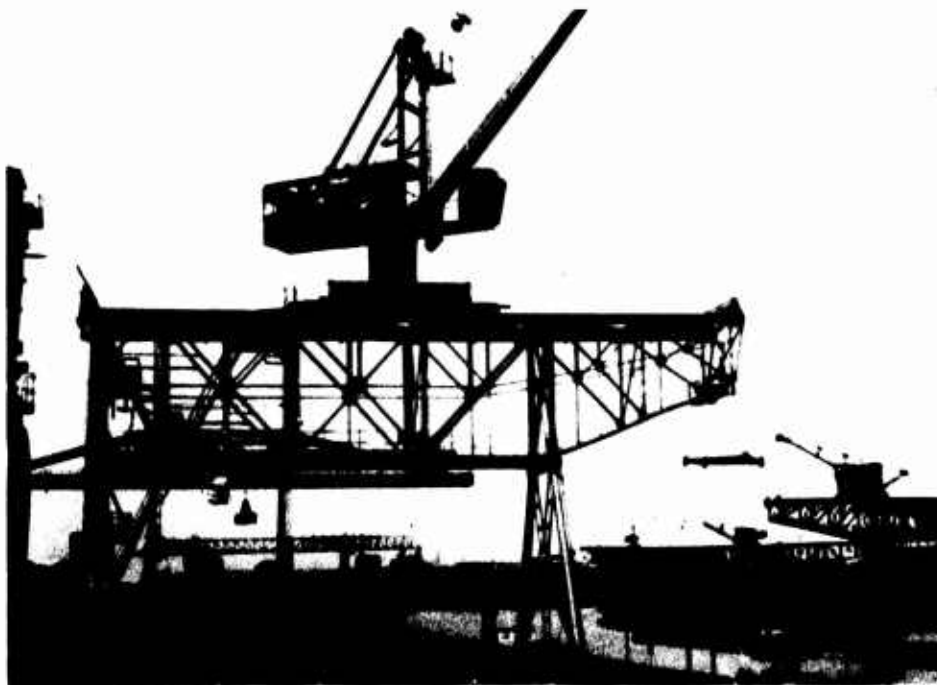
Figure 11-12. Vehicular loading on barge at Rheinau site.

e. A total of 496 pieces of equipment was loaded on 12 Rhine River barges (figs 11-12 and 11-13). Table 11-2 identifies in detail the equipment loaded on each barge.

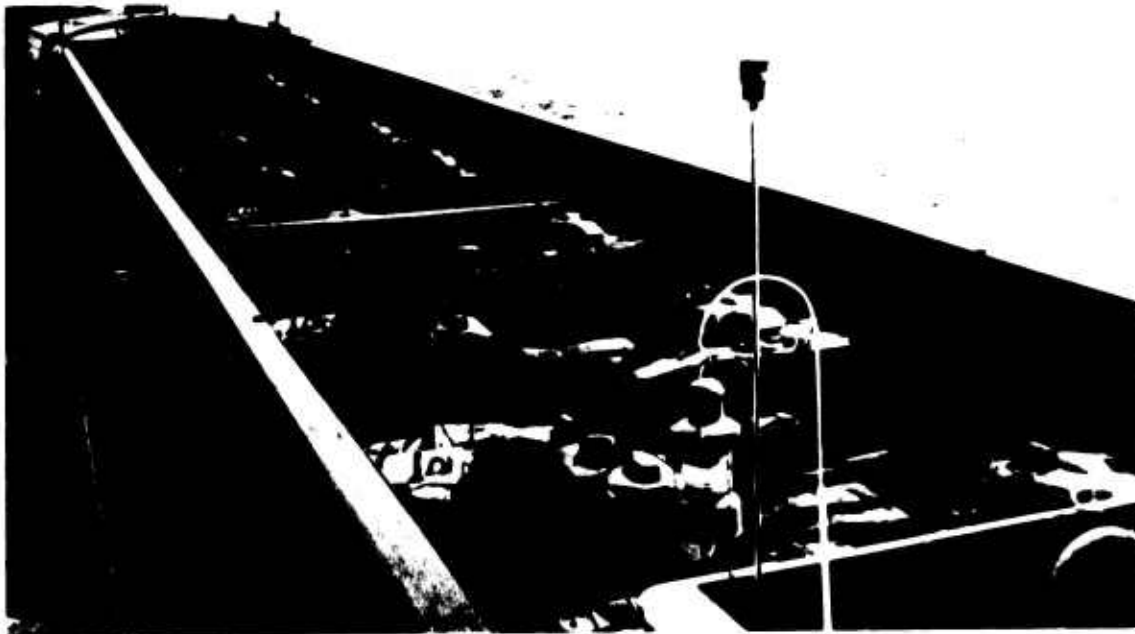
Figure 11-16. M-60 in barge.

f. The contractor made maximum use of barge-loading space. Trailers and 1/4-ton trucks were placed on cargo hatch covers (fig 11-14). Cargo was not secured on river barges since there is little risk of cargo shifting (figs 11-15 and 11-16). The three helicopters loaded into barges (figs 11-17 through 11-19) were blocked as a precautionary measure.

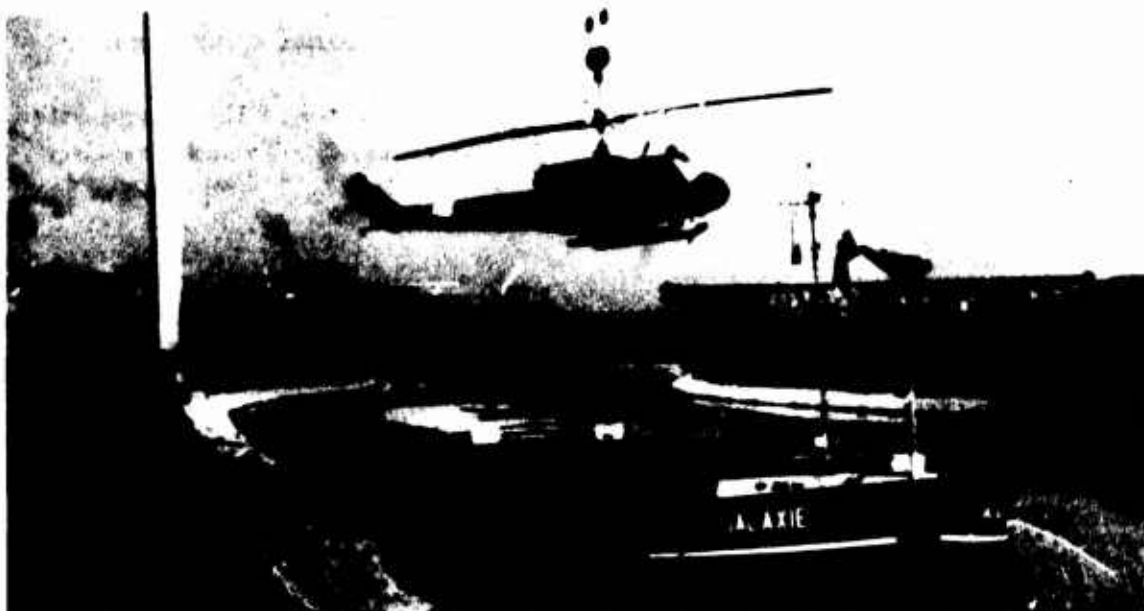
Figure 11-18. Helicopters loading aboard barge.

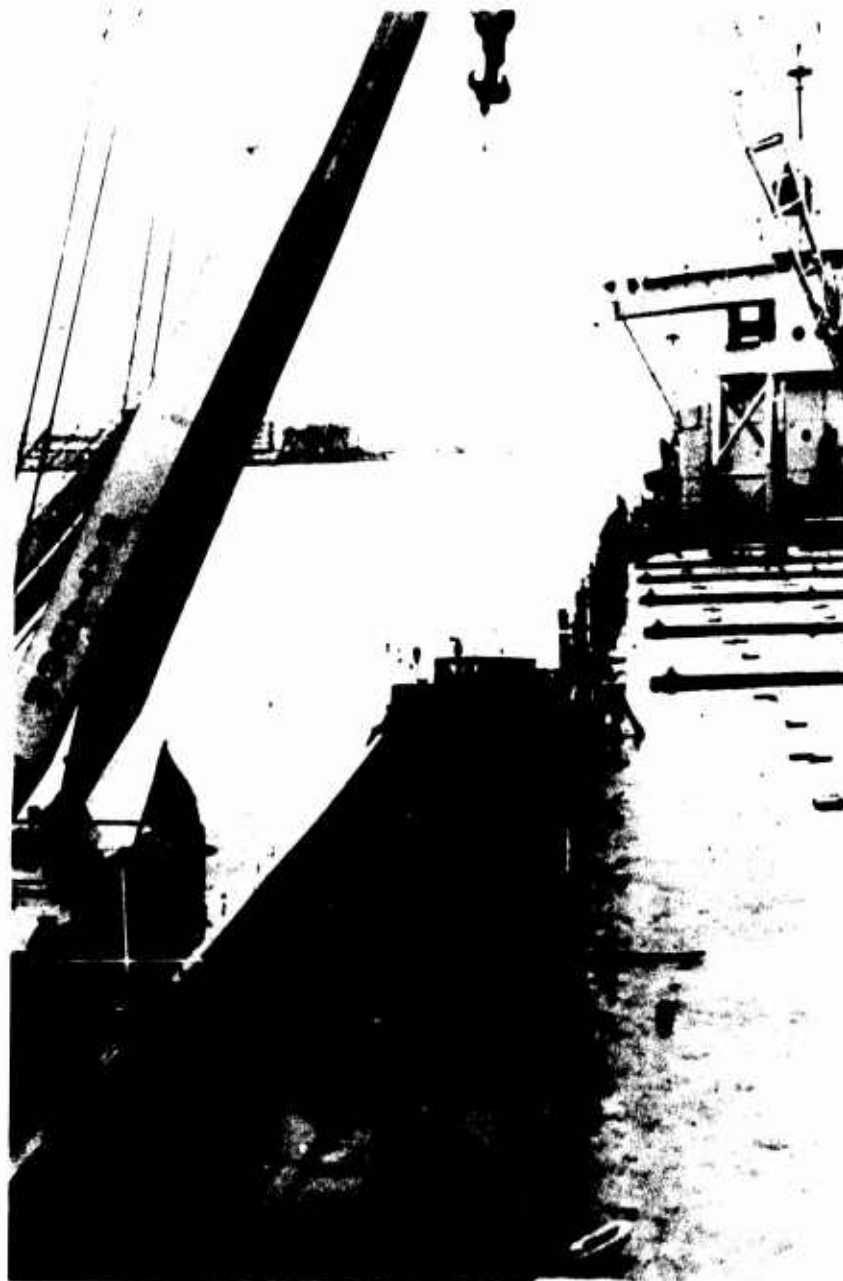
Figure 11-22. Floating crane loading tanks at Rotterdam.

d. The original concept was to load all cargo directly from barge to ship; however, at the discretion of the contractor, some cargo was unloaded from the barges onto the shore. (This did not result in any extra cost to the US Government.) A 46-metric-ton quay gantry crane was unable to lift M-60 tanks from outboard barges to the ship; consequently, the contractor used a floating crane to discharge M-60 tanks from barge to ship, again at no extra cost to the US Government (fig 11-22).

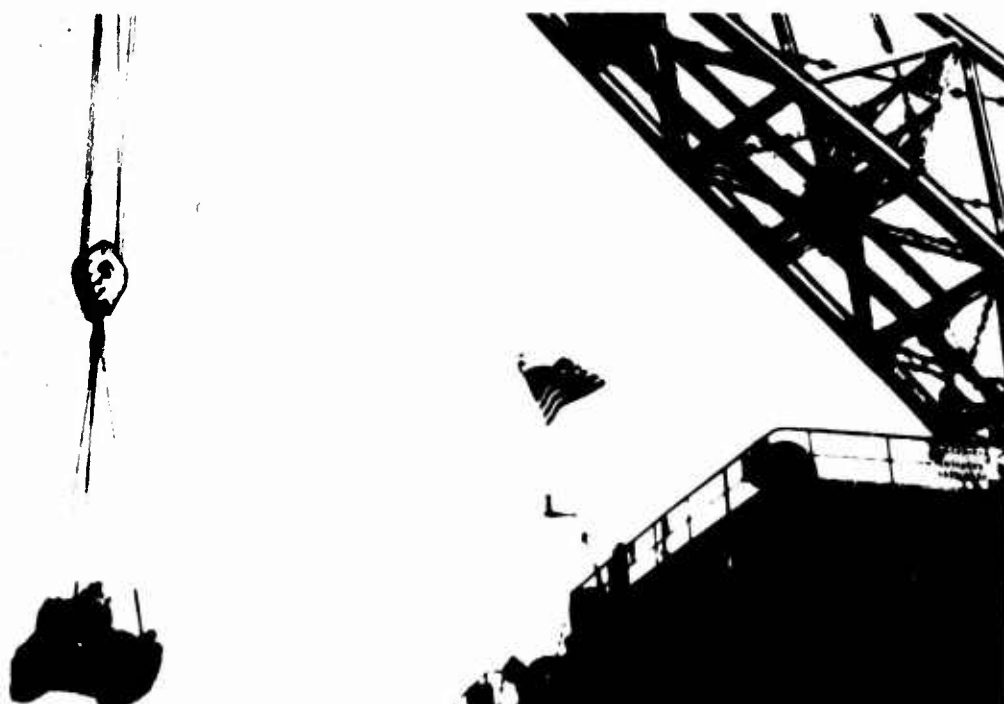
Figure 11-28. Loading operations at Bremerhaven.

c. The GTS Callaghan (fig 11-27) berthed at the Nordhaven dock in Bremerhaven on 4 October 1977 at 1200 hours. Loading operations commenced at 1100 hours, 6 October and were completed at 2130 hours, 8 October 1977. The GTS Callaghan (fig 11-28) was loaded in 59 working hours.

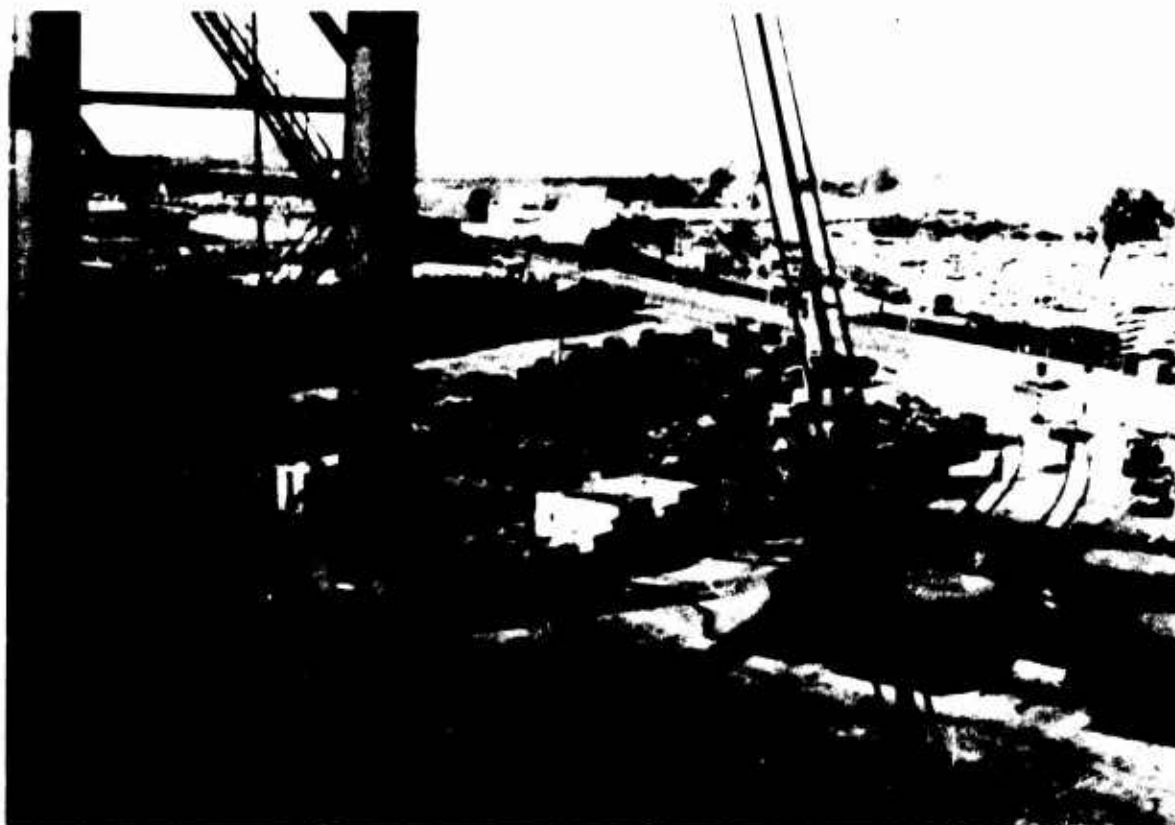
Figure 11-31. GTS Callaghan staging area.

(1) The lack of staging space, due to an overflow of other than REFORGER cargo (POVs and containers) in the port, prevented the unloading of some railcars until late in the shiploading operation; hence, the terminal operators were unable to select equipment for loading in the sequence and by the type desired (fig 11-31).

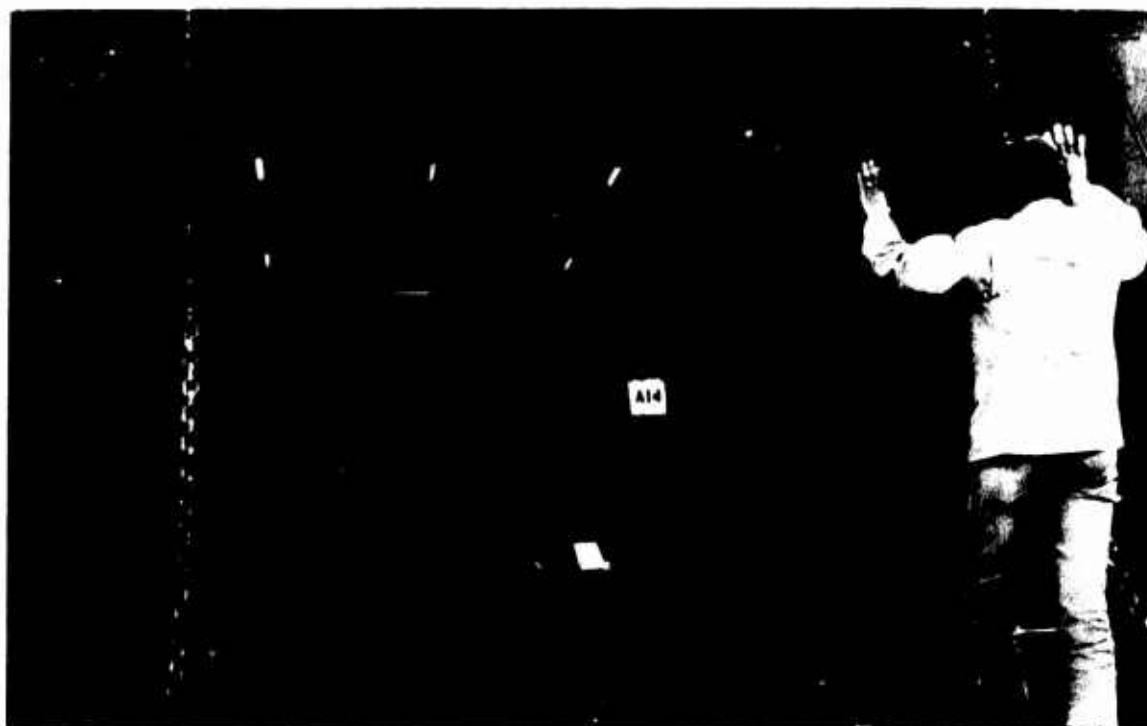
Figure 12-1. Tank drive-off from GTS Callaghan, stern ramp.

(3) REFORGER 77 equipment was driven off the GTS Callaghan through the stern and aft side ramps (figs 12-1 and 12-2). CONEXs at hatch number 1 and nonwheeled cargo on the main deck were lifted off, using ship's gear. Disabled vehicles both tracked and wheeled, stowed on the main deck, were lifted off onto barges, using a floating crane (fig 12-3).

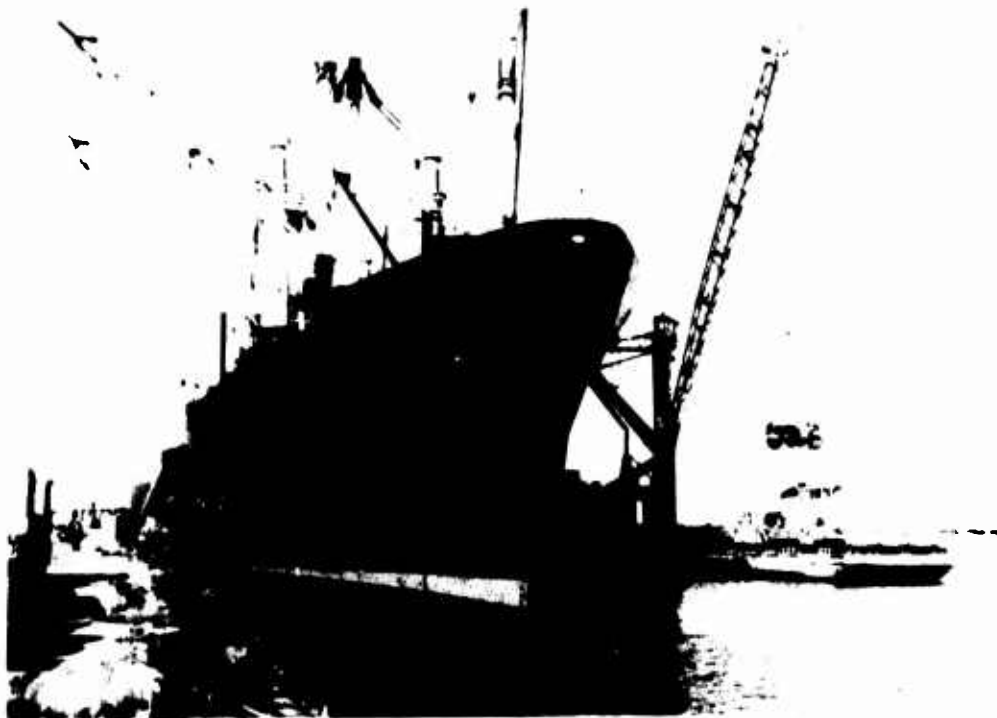
Figure 12-3. Floating crane discharge to barge.

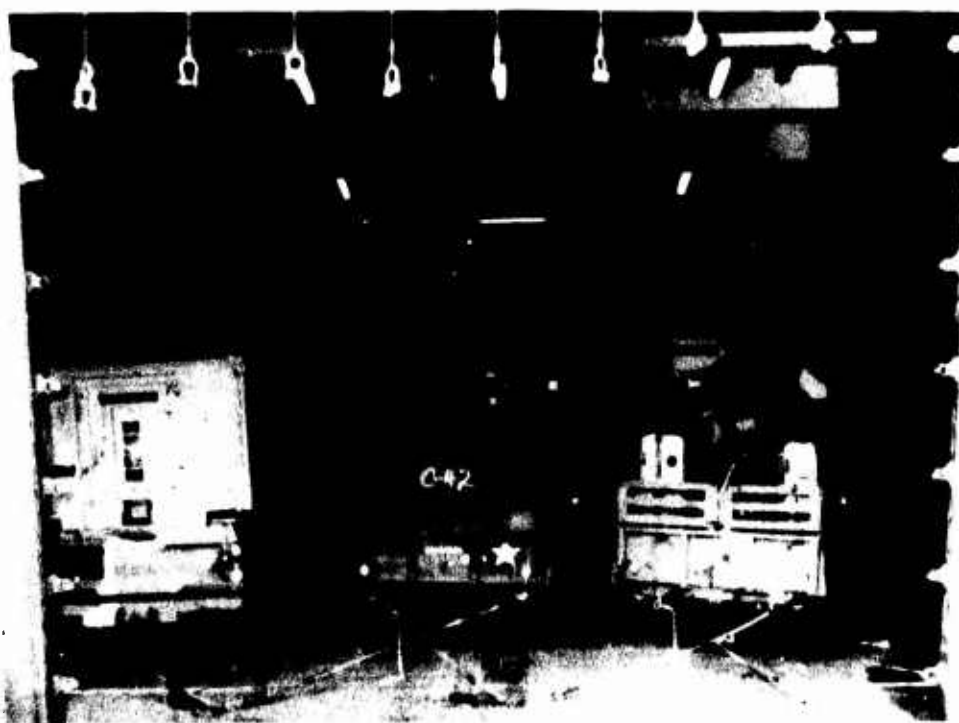
Figure 12-4. Stowage of vehicles on GTS Callaghan stern ramp.

(4) Roll-off operations were initially hampered as vehicles and trailers were loaded on the stern ramp and number 6 upper tween deck requiring that they be backed off during discharge (fig 12-4). During

backing operations, due to a brake failure, one M-52 5-ton tractor with an M-750 shop van "jack-knifed" on the stern ramp, resulting in minor damage to the van. Damage to the 5-ton tractor front bumper occurred while attempting to "right" the vehicles.

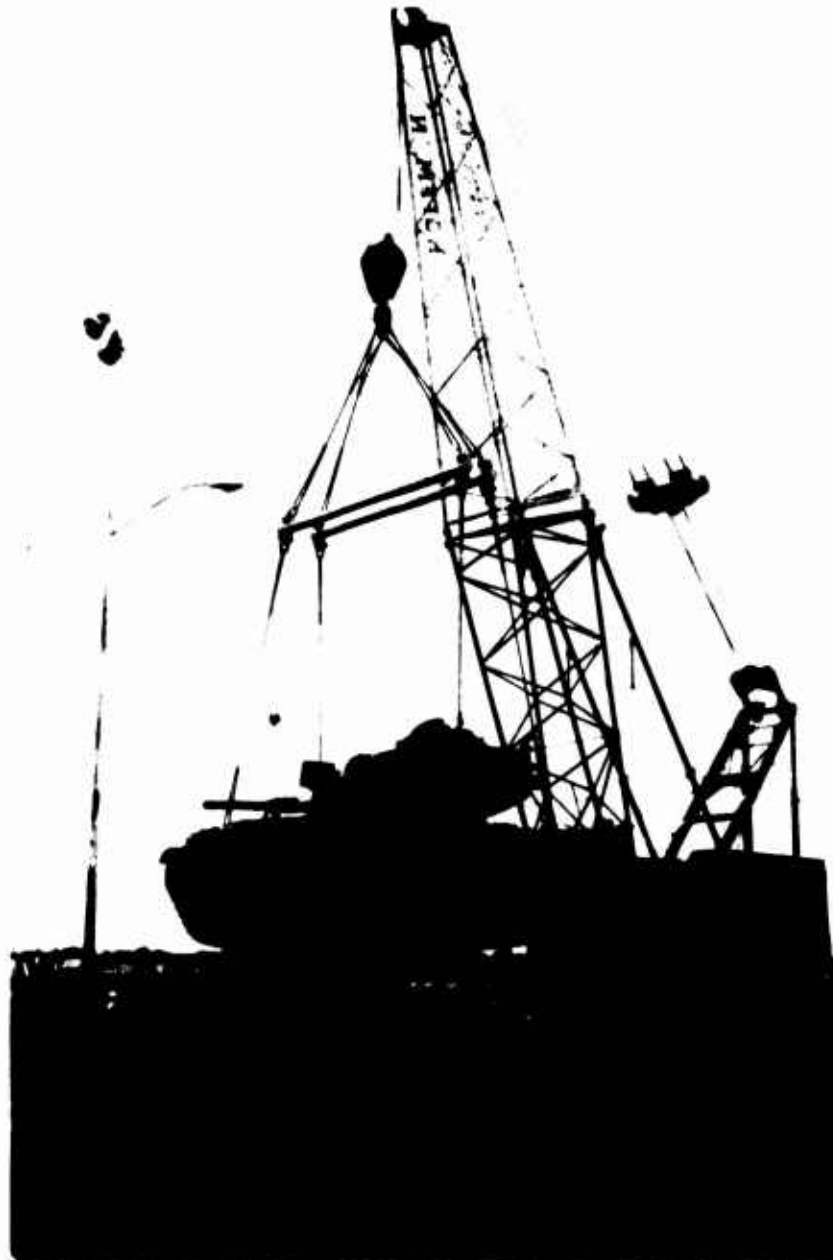
Figure 12-5. M-60 loading onto railcar.

(a) M-60 tanks, M-88 tank retrievers, and M-113 personnel carriers were lifted using a mobile crane onto prechalked railcars (figs 12-5 through 12-7). The lift-on method was necessary for the heavier M-60 and M-88 tracked vehicles, since MOTBY did not have a permanent or reinforced railcar end-loading ramp, although an end-loading ramp (fig 12-8) of sufficient strength and width was available to permit drive-on loading operations for M-113 personnel carriers and similar tracked vehicles. The decision was also made to load these lighter tracked vehicles by the lift-on method.

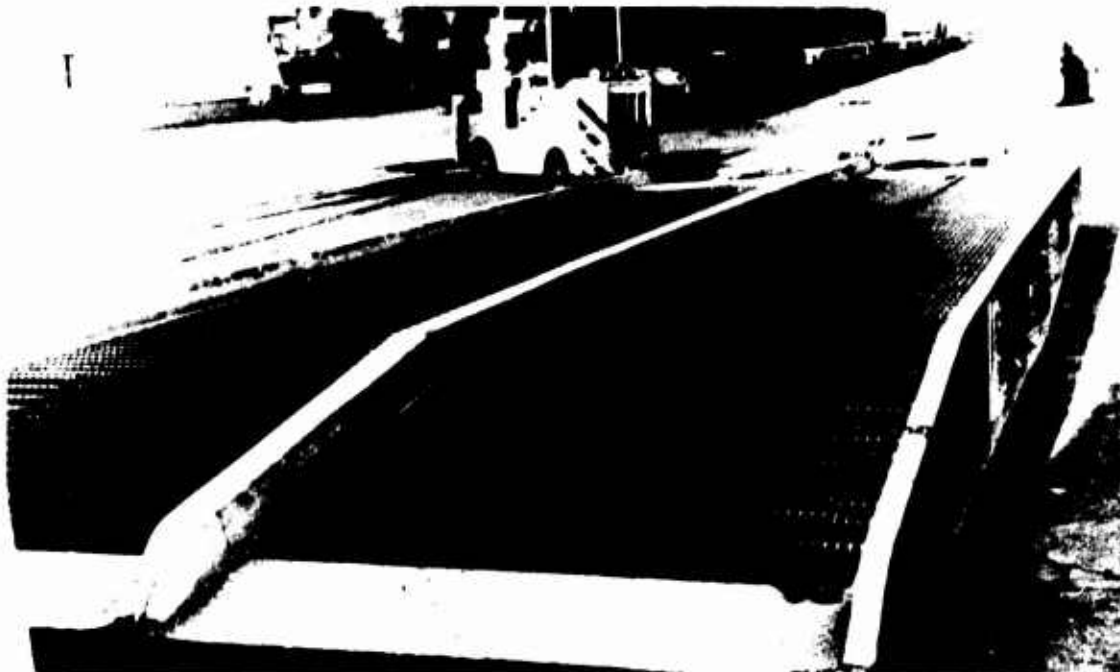
Figure 12-8. Portable end-loading ramp.

(c) Wheeled vehicles were driven onto flatcars using a portable end-loading ramp and sufficient railcar spanners to facilitate an efficient loading operation (fig 12-9).

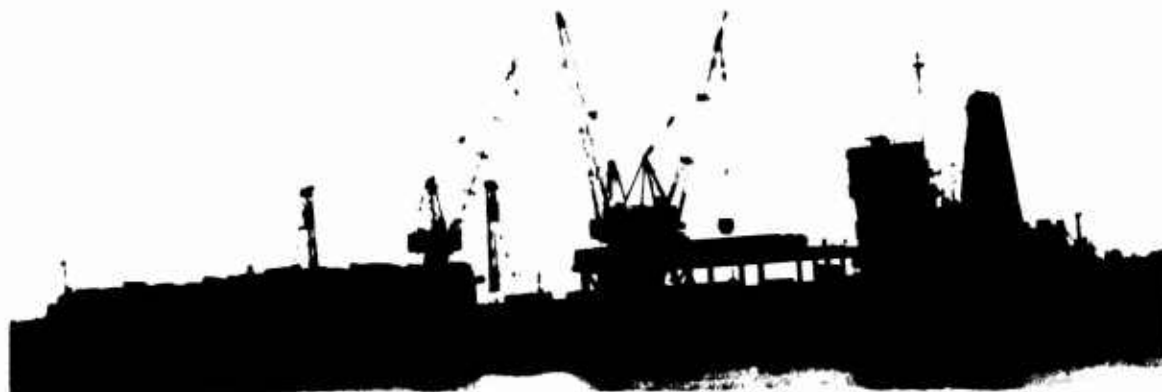
Figure 12-13. Discharge using ships' cranes and gantry crane.

(3) REFORGER 77 equipment was discharged from the spar deck by one gang using the gantry crane while main deck equipment was discharged by the second gang using the ship's crane (fig 12-13). After equipment was cleared from the spar and main decks, only one gang was employed to discharge cargo from the tween deck and tank top (fig 12-14).

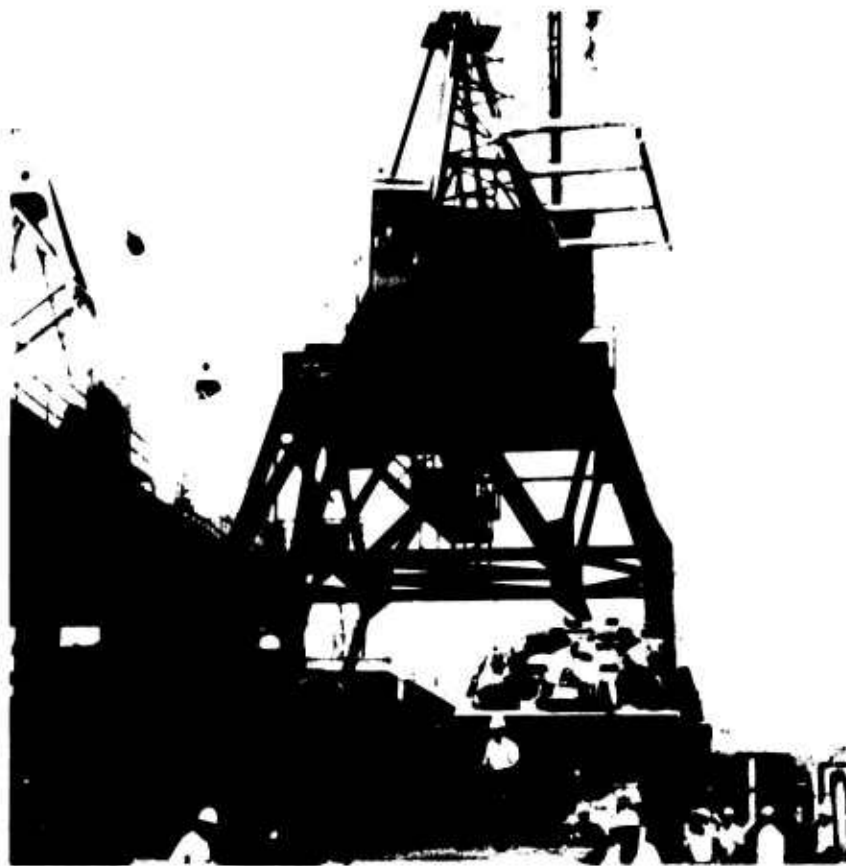
Figure 12-15. Direct ship-to-railcar discharge.

(2) Heavy equipment (M-60 tanks and recovery vehicles) was loaded directly to DODX 100-ton railcars (fig 12-15). Ship discharge was slowed somewhat by direct-to-railcar discharge; however, an overall time saving was realized since only one handling of tanks and recovery vehicles was necessary.

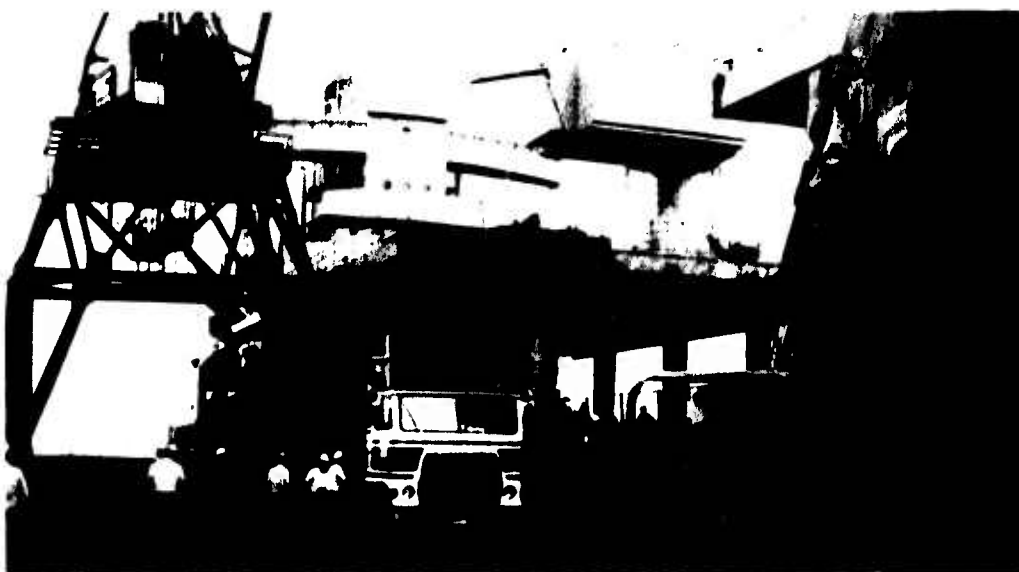
Figure 12-16. Direct ship-to-truck discharge.

(3) TOW carriers were loaded directly to awaiting commercial highway trucks (fig 12-16).

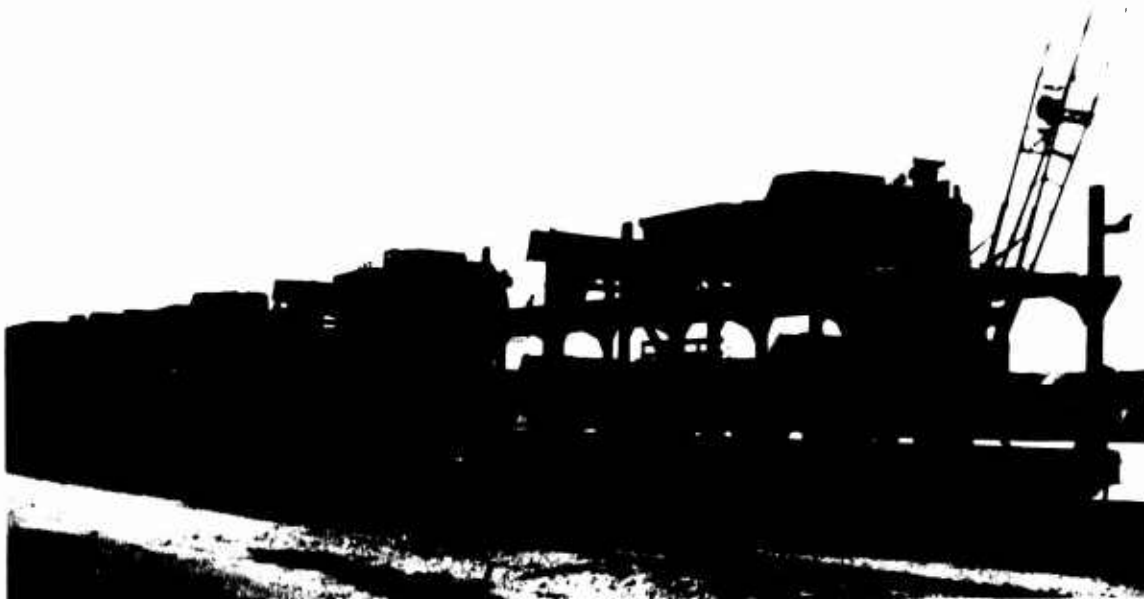
Figure 12-17. Railcar loads at Beaumont.

(a) Vehicular rail outloading on bilevel (fig 12-17) and dunnage-free, chain-tiedown flatcars progressed simultaneously with vessel discharge (fig 12-18). Not all chain-tiedown cars were adequately equipped with tiedown devices. Railroad officials procured the additional necessary equipment, and auxiliary wire safety tiedowns were applied by port personnel.

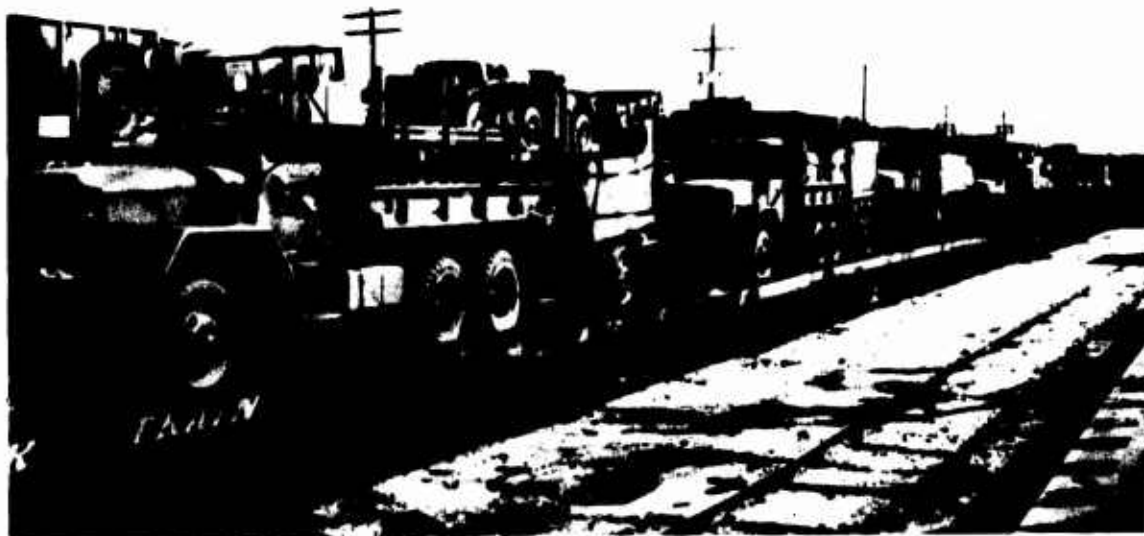
Figure 12-18. Railcar loads at Beaumont.
